Natural Microsponges Coat Underwater Plants to Help Control Hydrilla

(by Janet Beall and Rick Swift, Pinellas County, 22211 US Highway 19 North, Clearwater, Florida 33765; Rick Lowe and L. Marshall, Ph.D. TAPT, 5988 Mid Rivers Mall Drive, Suite 124, Saint Charles, Missouri 63304)

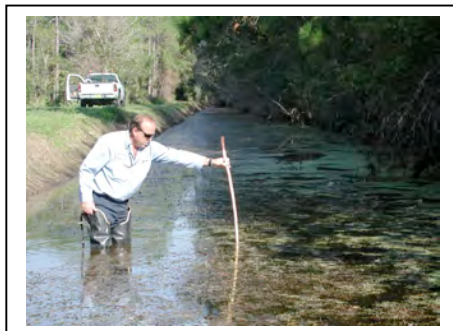
Fig. 3: Rick Swift Measuring Acre-Foot of Drainage Ditch for Rate of Application Determination

To test the concept, Pinellas County staff applied various tests in a drainage ditch containing hydrilla that had minimal flow rate. Three separate trials were constructed. All trial areas were measured (Figure 3) by acre-foot. Each trial area was separated by a 25 foot buffer zone. The first area was (75 ft x 22 ft x 2 ft deep), where no herbicides were used called Zone #3 (Figure 4). The second was a herbicide (alone) area (75 ft X 22 ft X 2 ft deep) called Zone #2, which had the same amount of hydrilla density. The third was a herbicide with micro sponge tank mix application in area called Zone #1. The trials are summarized as follows:

The entire treatment area had equal morning shade from trees to the east, equal afternoon sun allowed by an open field to the west, and was uniformly full of Hydrilla (Figure 3).

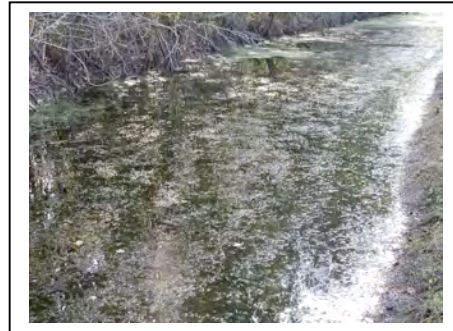
Fig. 4: Hydrilla Check (Untreated) Zone #3

Finally, another 25 foot buffer zone was set up, which was followed by a 75 foot untreated control area (as a check point) (Zone #3).

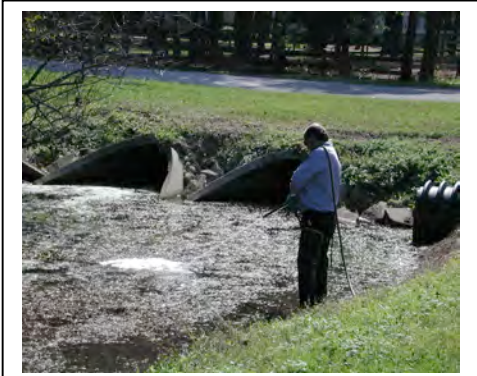
Fig. 5: Hydrilla Treatment Day – Using a Handgun Attached to a Truck Spray System.

At the start, a 20 foot buffer was set next to a pipe opening in the ditch. Right next to the buffer area, a 75 foot area (Zone #1) was treated with 26 oz of Aquathol K with 0.64 oz of TopFilm™ adjuvant. This rate translates to 4 ppm Aquathol K with 16 oz of TopFilm™ per acre. (Figure 5)

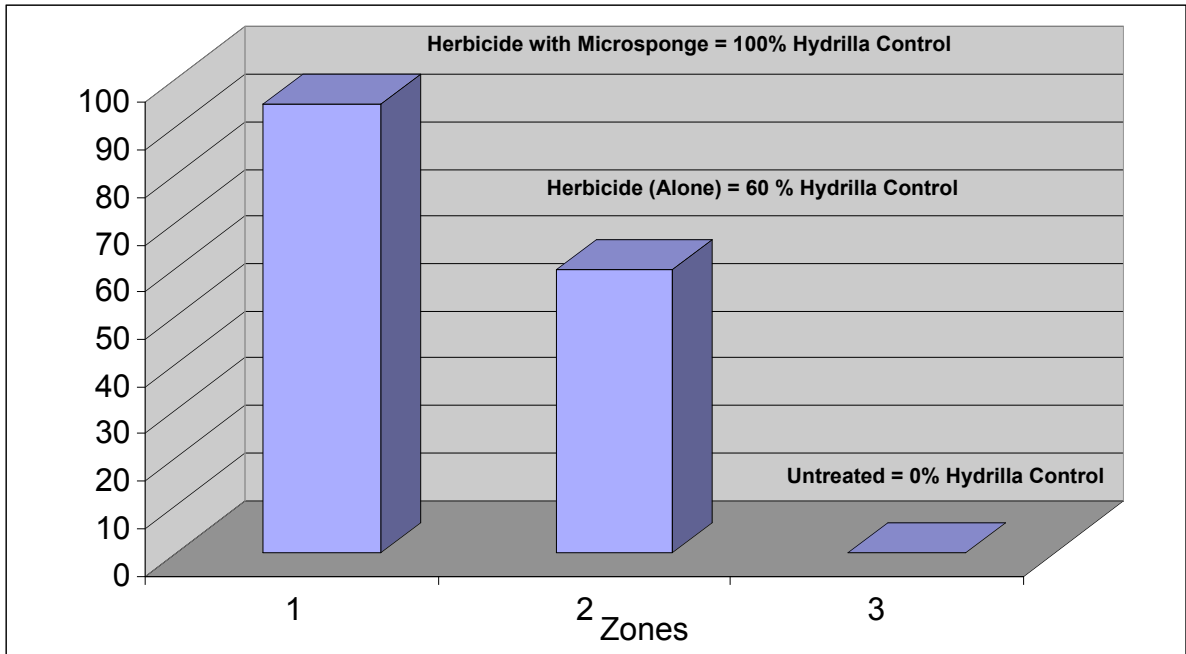
Fig. 6: Results Six Weeks After Treatment (6 WAT) shows the Zone 1 “Herbicide with Microsponges” had 100% Hydrilla Control; Zone 2 “Herbicide Alone” had 60% Hydrilla Control; and Zone 3 “Untreated Control” had 0% Hydrilla Control

Six weeks after treatment (6 WAT), the results showed: Zone #3 was still packed with Hydrilla (0 % Hydrilla Control); Zone #2 Hydrilla remained at 50 - 60% Hydrilla Control; and Zone #1 had no hydrilla present (100% Hydrilla Control).

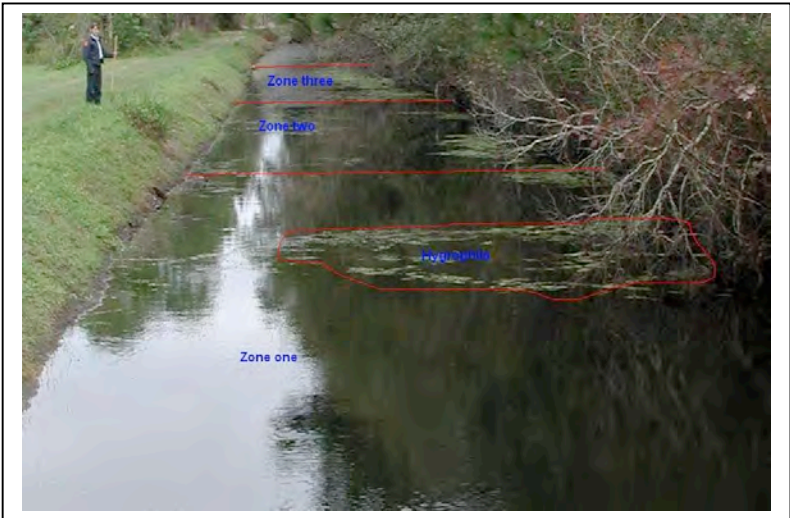
Fig. 8: Summary Picture After Six Weeks (6 WAT) Showing the Treatment Zones and the Hygrophila Patch

As shown in the picture in [Figure 8](#), there remained a patch of hygrophila (*Hygrophila polysperma*), which is not controlled with the rate of 4 ppm Aquathol K.
